# DAMALANCHE: AVALANCHE DAMMED RIVER

**ABSTRACT:** January 2014 brought an unseasonably warm and prolonged low-pressure system to Alaska. Heavy precipitation associated with above freezing temperatures created an eighteen-day avalanche cycle. Large avalanches dammed and flooded the Lowe River. The Richardson Highway, bridges through Keystone Canyon and residential areas were threatened by the possibility of outburst flooding.

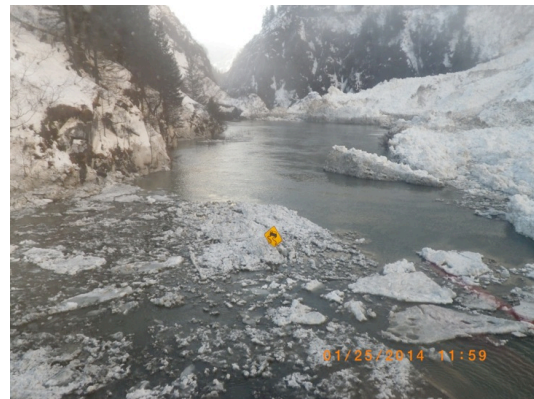
Fig. 1: Damalanche. Avalanche dammed lake flooding Richardson Highway.

The term, ‘avalanche dam’, often refers to avalanche control structures built in run-out zones to deflect or catch avalanche debris. During the winter of 2014 Valdez, Alaska had a different kind of avalanche dam – a dam of wet entrainment avalanche debris that blocked the Lowe River and temporarily formed a new lake. The townspeople of Valdez dubbed it the ‘Damalanche’ (Fig.1).

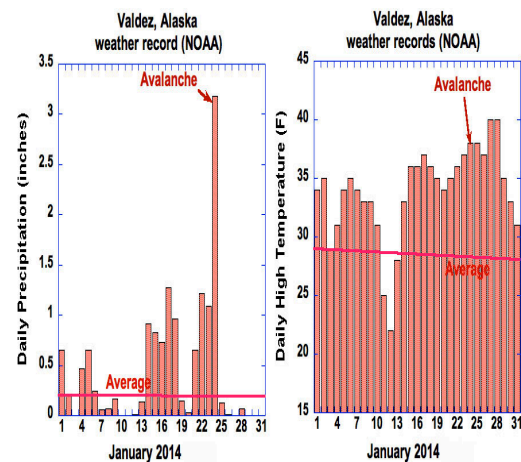
Fig. 3: Precipitation and Temperature record (NWS Valdez, NOAA).

Precipitation was steady from January 13<sup>th</sup>-22<sup>nd</sup> and then increased in intensity through the 25<sup>th</sup>. Manual snowfall and snow water equivalent measurements at Thompson Pass measured twenty-three inches (600mm) of precipitation added to the snowpack from January 13<sup>th</sup>-25<sup>th</sup>. The 19 Mile RWIS station recorded twelve inches of (300mm) of precipitation during the twenty-four hours from 2pm January 22<sup>nd</sup>-23<sup>rd</sup>. The 12 Mile RWIS station reported more than twenty-one inches (530mm) of precipitation from January 21<sup>st</sup> 2pm-January 24<sup>th</sup>. Various observers and the National Weather Service office anecdotally verified these amazing quantities. The Valdez NWS reported more than three inches (80mm) of rain during twenty-four hours of January 23<sup>rd</sup>-24<sup>th</sup> (Fig. 3).

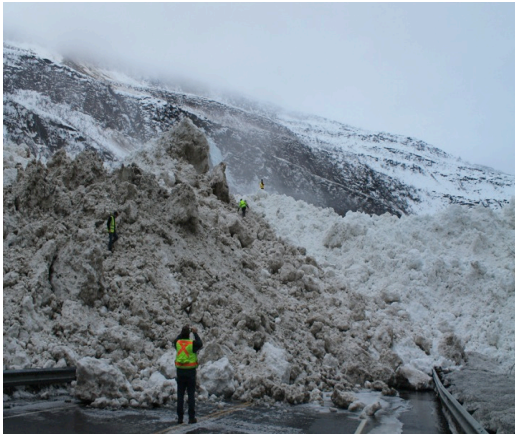
2000 feet (600m) of road was buried with wet debris over 140 feet (40m) deep. The entire deposit of multiple avalanches piled on top of one another in the river valley was estimated to *average* 2000 feet long by 500 feet wide by 75 feet deep (600m X 150m X 23m = 2,070,000 m<sup>3</sup>) equaling 75 million cubic feet of snow (more than 2 million cubic meters) with debris weighing 500 kg/m<sup>3</sup>.

Fig. 4: AKDOT crew surveying Damalanche and buried highway.

Working around the clock for 139 hours (5.8 days), twenty-four workers using a Hitachi 450 excavator, four bulldozers including a Cat D8, four front-end loaders and three rock trucks removed 100,000 tons of snow from the highway (Fig. 4). The highway closure lasted more than 12 days.

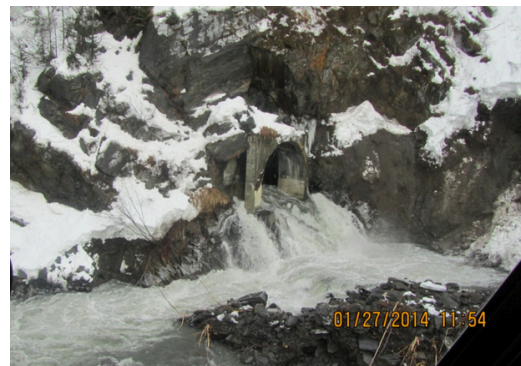
Fig. 5: Old highway tunnel allowing drainage

Fortunately, the water found a hydraulic pathway in the old highway tunnel. The tunnel had not been used since the 1970's when bridges replaced it as the road was upgraded for the construction of the 800-

mile (1300km) oil pipeline (Fig. 5). The upstream tunnel entrance had been buried by decades of mass wasting. It was also deeply buried by Damalanche debris.

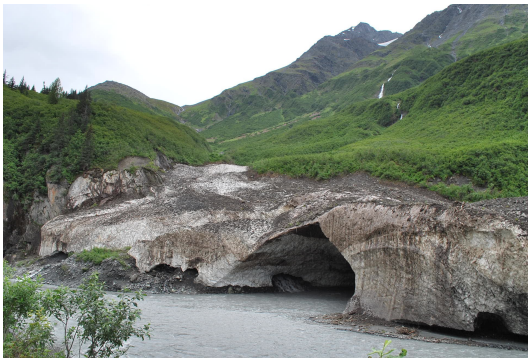
The Damalanche became a summer attraction for tourist and locals alike. Avalanche debris remained in the valley floor throughout the summer (Fig. 7).

Fig. 7: Remains of the Damalanche August 4, 2014.
